Manhole Inspection Summary

Manhole # S17MM_001MH

Insp Date: **6/6/07 10:59 AM**

Location Address: **2301 WINDSOR AVE**

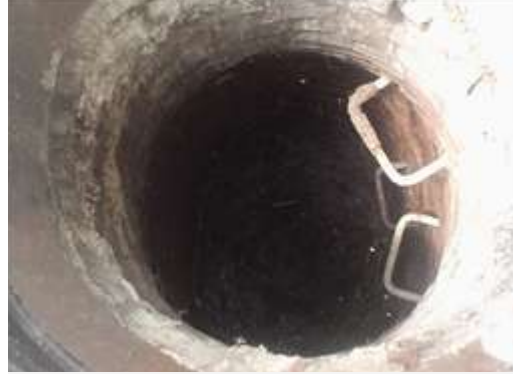
Defect 1

CHANNEL ROOT INTRUSION

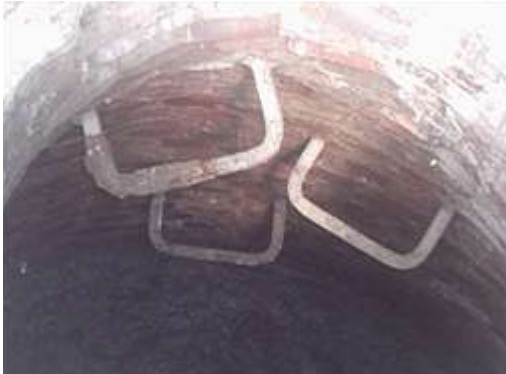
Defect 4

Steps Count: **3** Missing: **0** ☒ **Corroded**

CORRODED STEPS

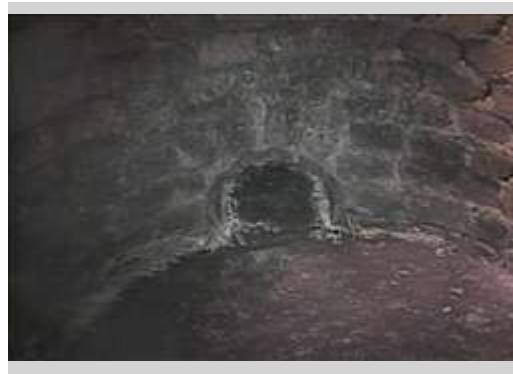
Defect 2

Condition: ☐ Sound ☐ Cracked ☒ **Root Intrusion** ☐ Deteriorated ☐ Leaks ☐ Debris

CHANNEL ROOT INTRUSION

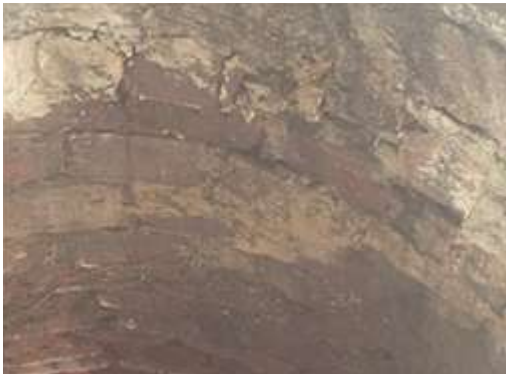
Defect 3

Condition: ☐ Sound ☐ Cracked ☐ Root Intrusion ☒ **Loose Brick** ☒ **Deteriorated**

DETERIOATION OF CHIMNEY

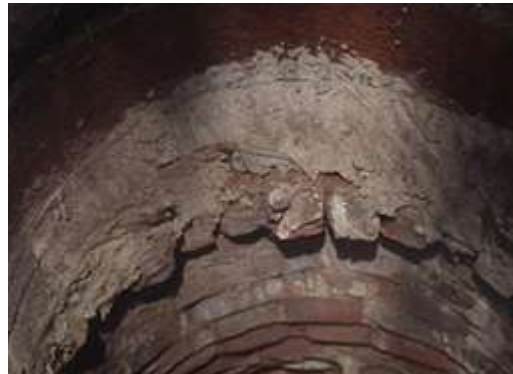
LOOSE CHIMNEY BRICKS

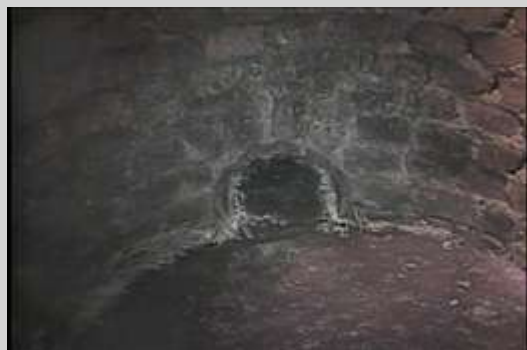
12 O'Clock Outflow

8 in. Circular Gravity Sewer
Pipe Out @ 12 O'Clock

Infiltration: **None** Pipe Seal Cond: **Roots**
